Recreational Use Attainability Analysis for Buffalo Creek (0214B), Paradise Creek (0230A), and Sweetwater Creek (0299A) in the Red River Basin

DRAFT for PUBLIC REVIEW

Prepared for:
Texas State Soil and Water Conservation Board
Project 12-52

TR 1308

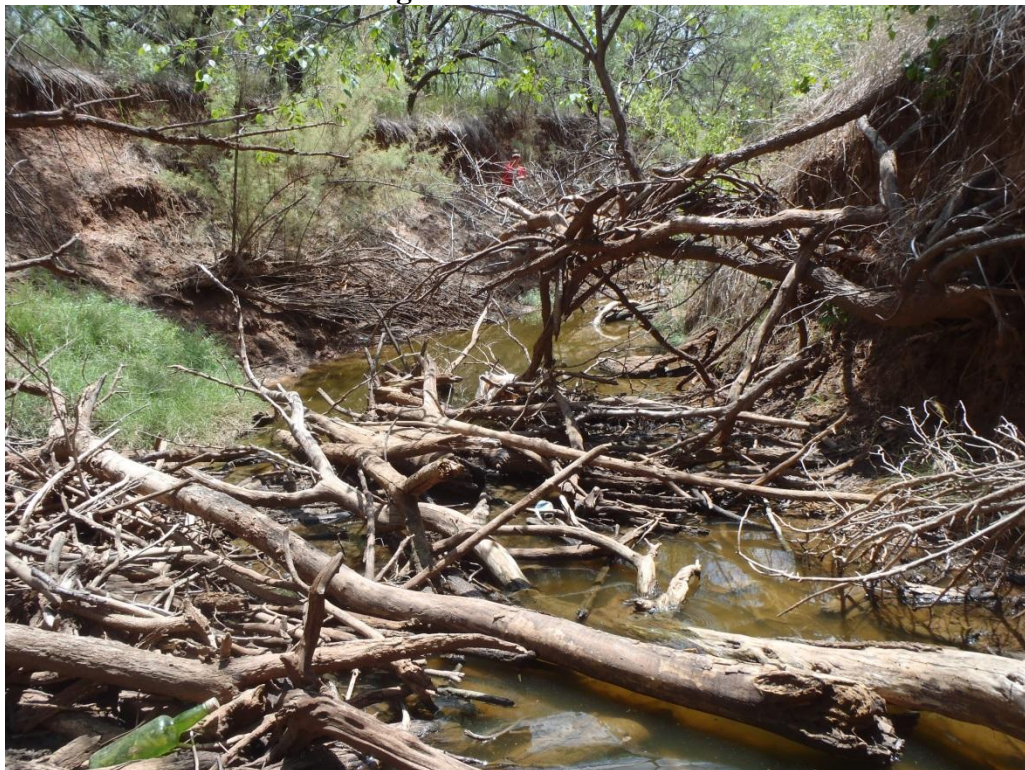
Figure 3.9 Photograph of BF003 taken on July 20, 2013, downstream view at 30-m transect. Note significant debris accumulation.

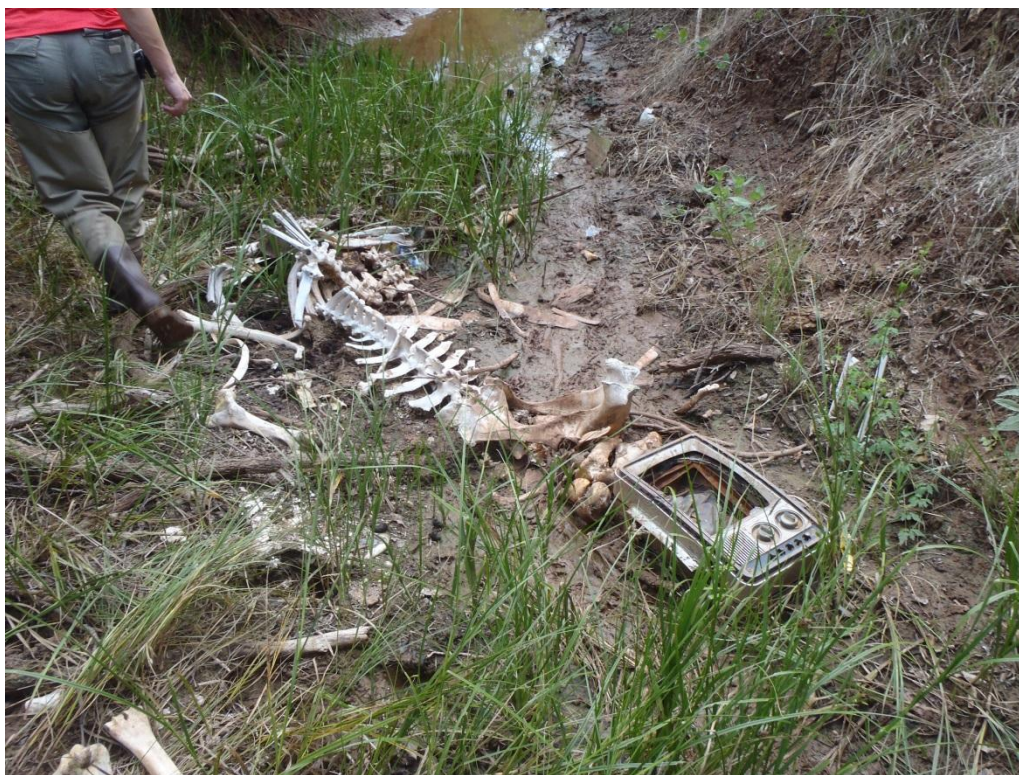
The stream channel was naturally vegetated with a variety of shrubs at the banks, clearing out to pasture beyond the banks (Table 3.5). Some aquatic vegetation including cattails were present but rare. The water surface was predominantly clear with a brown coloration and an occasional foul odor (Tables 3.9 and 3.10). Neither wildlife nor livestock were observed during the first survey but during the second survey snakes, crayfish, tadpoles, and horses were seen in the creek. Tracks of cattle, raccoon, skunk, small mammals, and dove were observed in addition to a cow carcass and some dead crayfish. Feces of birds, horses and cows were seen as well. Large garbage was observed at the bridge where it appears to have been discarded along with carcasses of various other animals including deer (Figure 3.10). Garbage ranged from a television and feed sacks to a vacuum cleaner, tires, and various glass bottles. Cardboard from fireworks that had been set off in the creek bed beside the water were documented; the only evidence of recreation observed. No other signs of human recreation were observed.

Figure 3.10 Photograph of Site BF003, downstream view at 30-m transect. Note animal carcass and television. TIAER personnel in photograph.

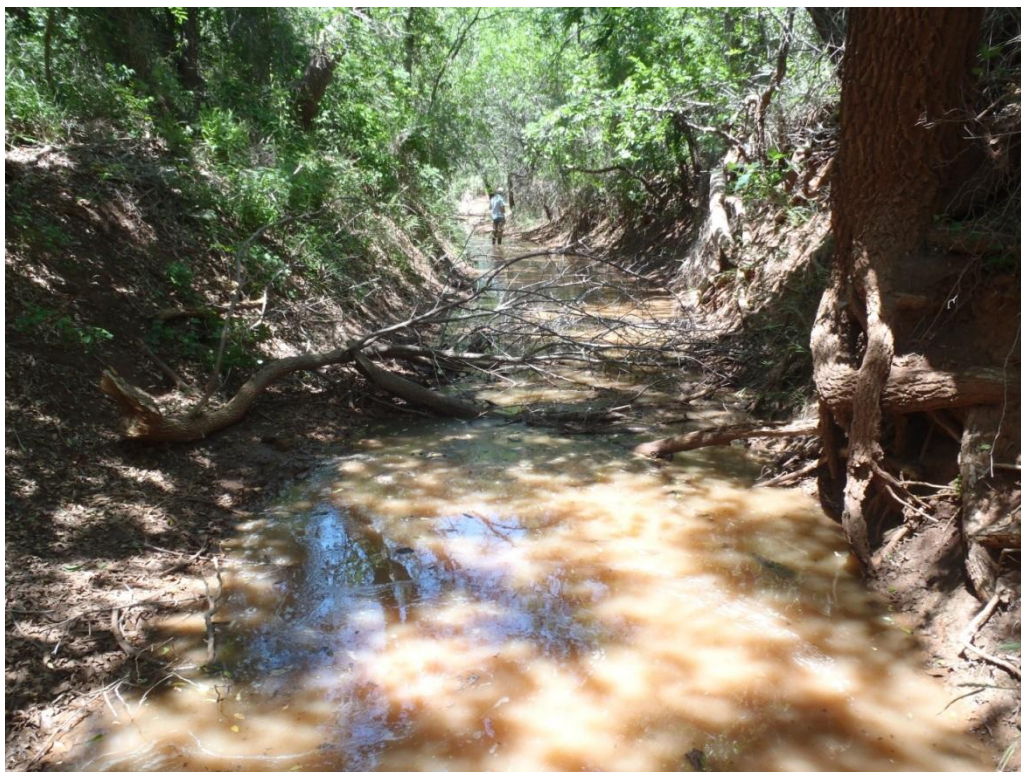
Most of this stream was shaded by native forest and shrubland vegetation on both sides of the corridor (Table 3.5 and Figure 3.12). Banks were steep in places but broken down in others where livestock entered the creek. The creek bottom was primarily a fine sediment mud. The water surface was clear and the color of the water was a reddish brown. Wildlife evidence included tracks of hog and deer, feces of bird and cow, gnaw marks of a beaver, and a half of a clam shell observed in the stream channel. Minimal garbage was seen including a plastic jug and a glass bottle (Tables 3.9 and 3.10). No evidence of human recreation was observed.

Figure 3.12 Photograph of BF004 taken on June 8, 2013 of log obstruction near the 30-m transect. TIAER personnel in photograph.

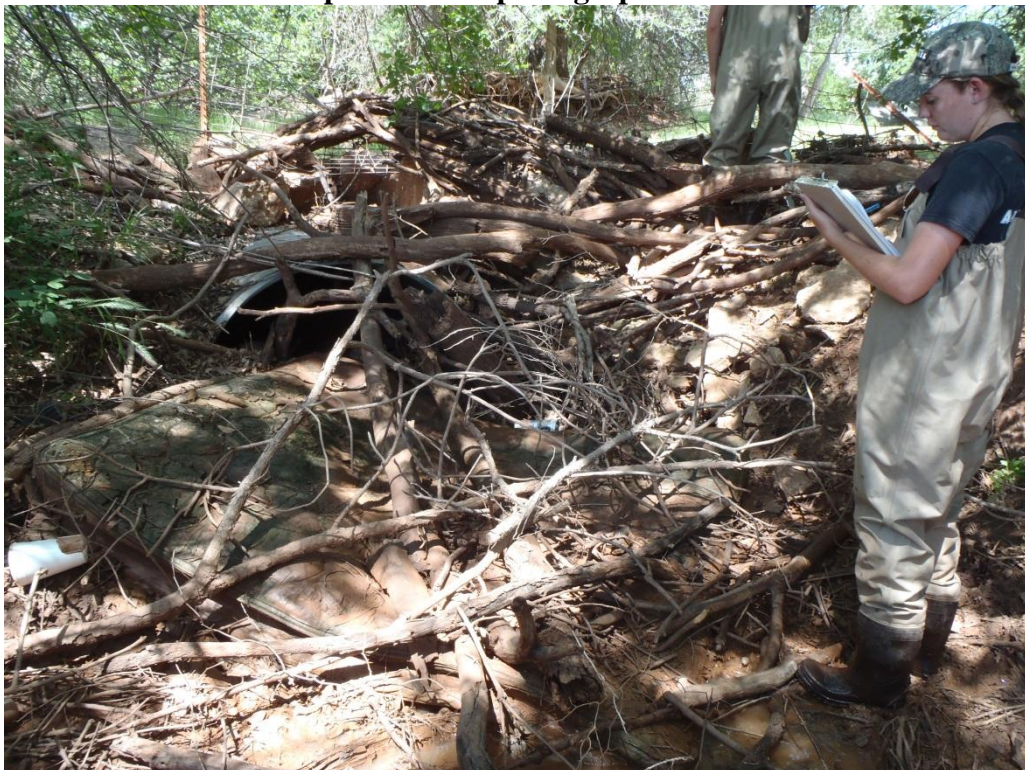
Figure 3.14 Photograph of BF005 taken on June 8, 2013 of mattress and logs jamming the culvert. TIAER personnel in photograph.

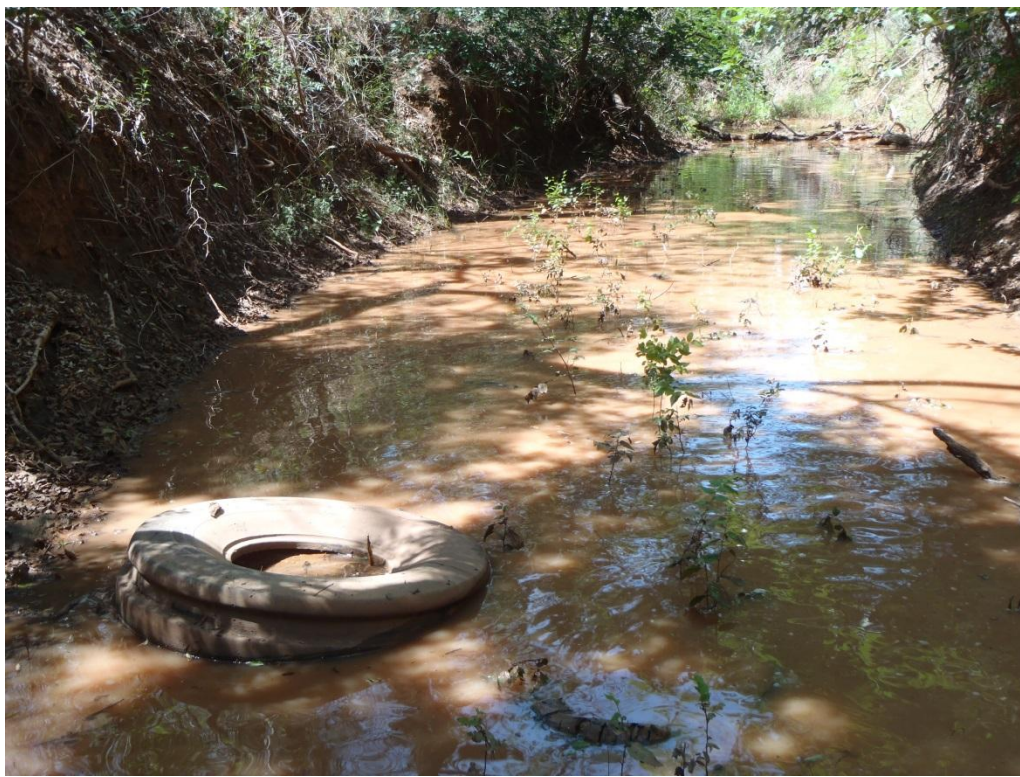
The water surface was clear and the color was brown (Figure 3.15). The creek bottom was a fine sediment mud, which contributed to some of the difficulty in walking. Hazardous vegetation including poison ivy (*Toxicodendron* sp.) was prolific.

Figure 3.15 Photograph of Site BF005, upstream view at 150-m transect. Note tire and log jam.

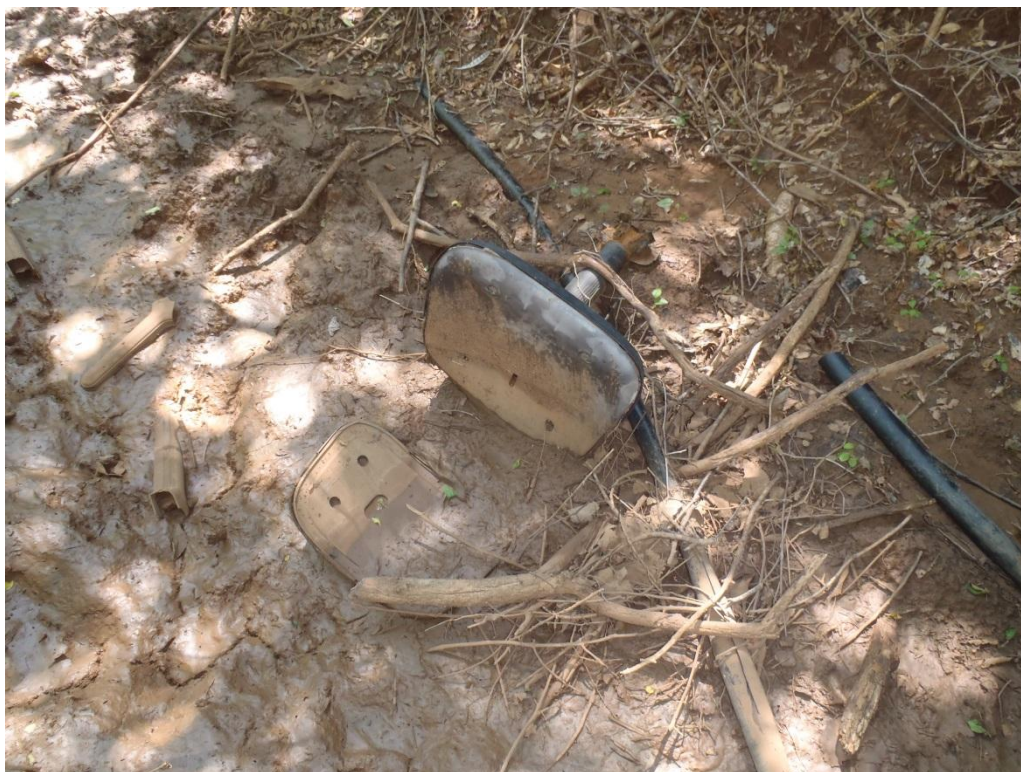
The riparian corridor at this site was primarily native shrub community with interspersed trees (Table 3.5). The creek bottom was a fine sediment mud. The water surface was clear and the color was clear during the first survey, but during the second survey, however, there was considerably less water and it had a brown coloration (Tables 3.9 and 3.10). Wildlife evidence observed included tracks of canine, large cat, raccoon, and deer. Cattle tracks were also seen. Garbage was rarely encountered, but included a discarded office chair and a glass insulator (Figure 3.19). No evidence of human recreation was observed.

Figure 3.19 Photograph of Site BF006 taken July 20, 2013, broken office chair in stream.

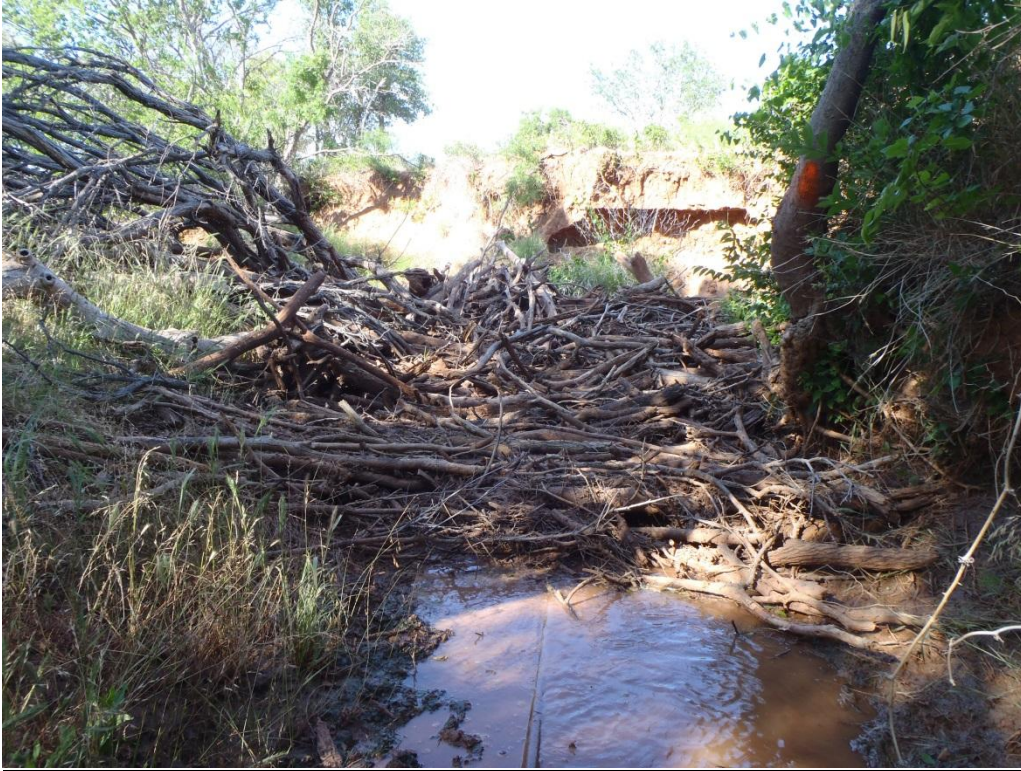
Figure 3.24 Photograph of Site BF008, taken on June 8, 2013 of a large log jam at 210-m. Note the steep bank beyond the jam.

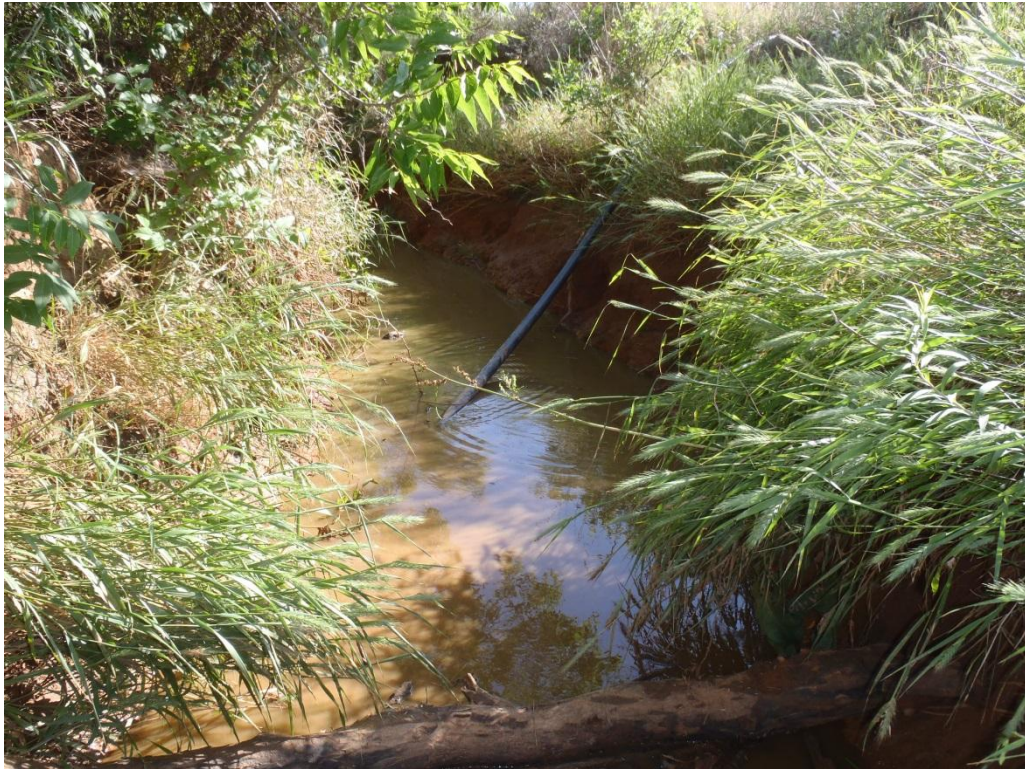
Figure 3.29 Photograph of BF010 taken on June 8, 2013, at 190-m transect. Note narrow channel, dense vegetation and pipe in stream.

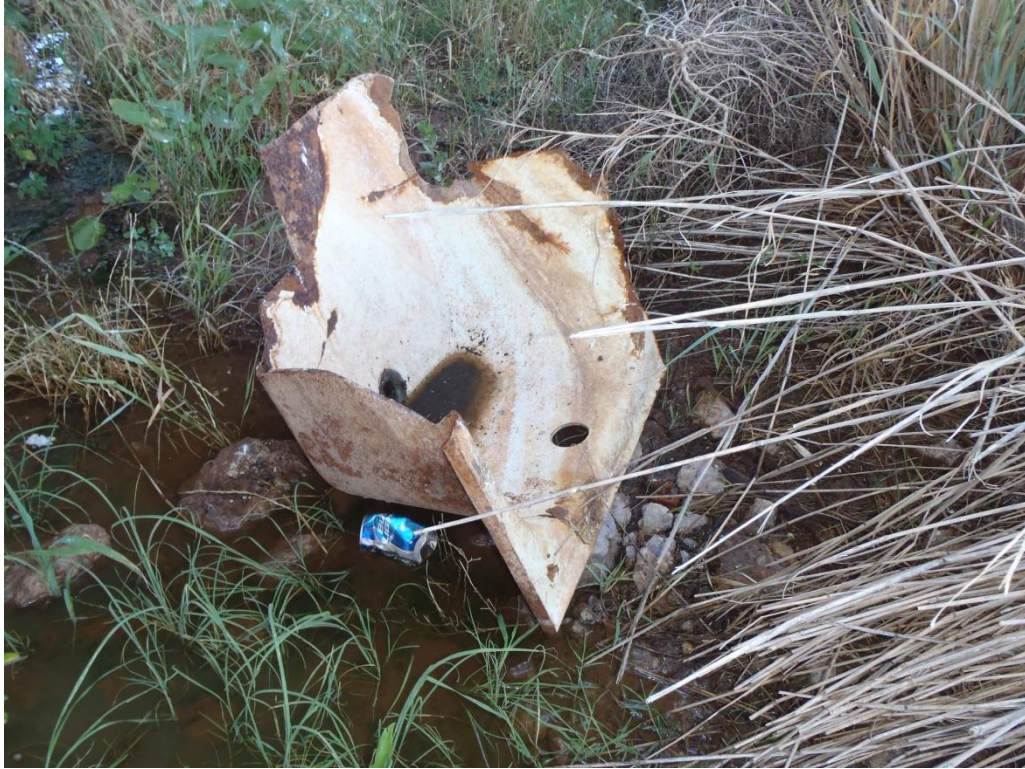
Figure 4.5 Photograph of site PD001 taken August 11, 2013 of bathtub and aluminum can garbage.

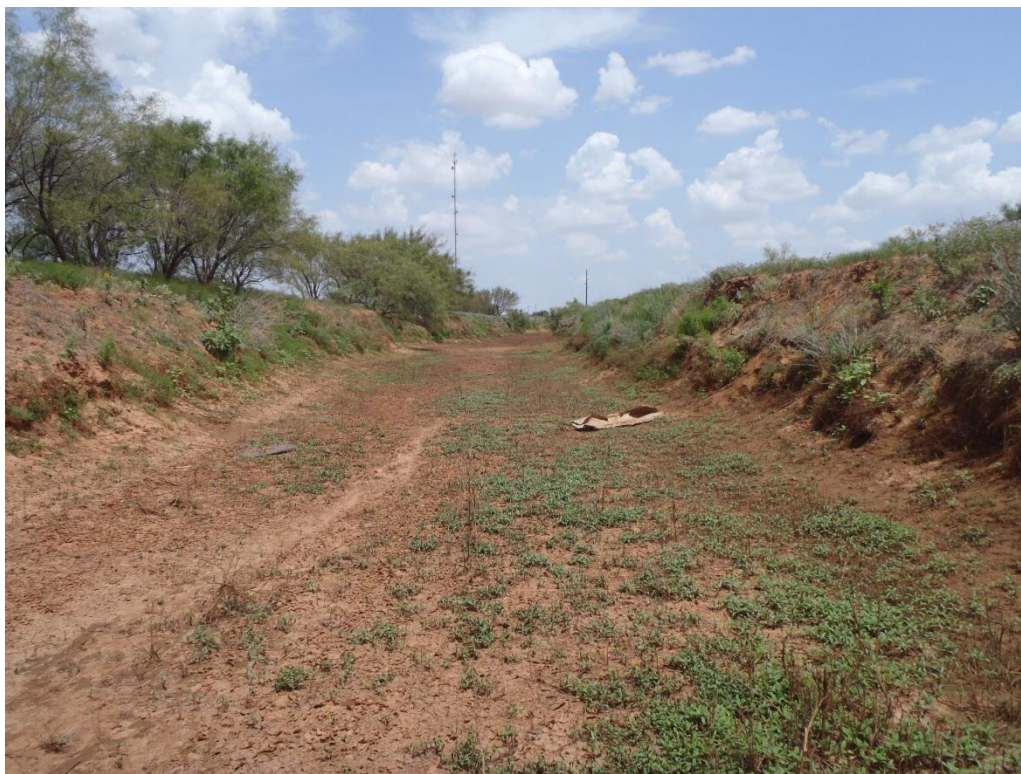
Figure 4.8 Photograph of PD002 taken on August 11, 2013. Downstream view at 300-m transect. Note the steep banks, lack of water, and cardboard garbage.

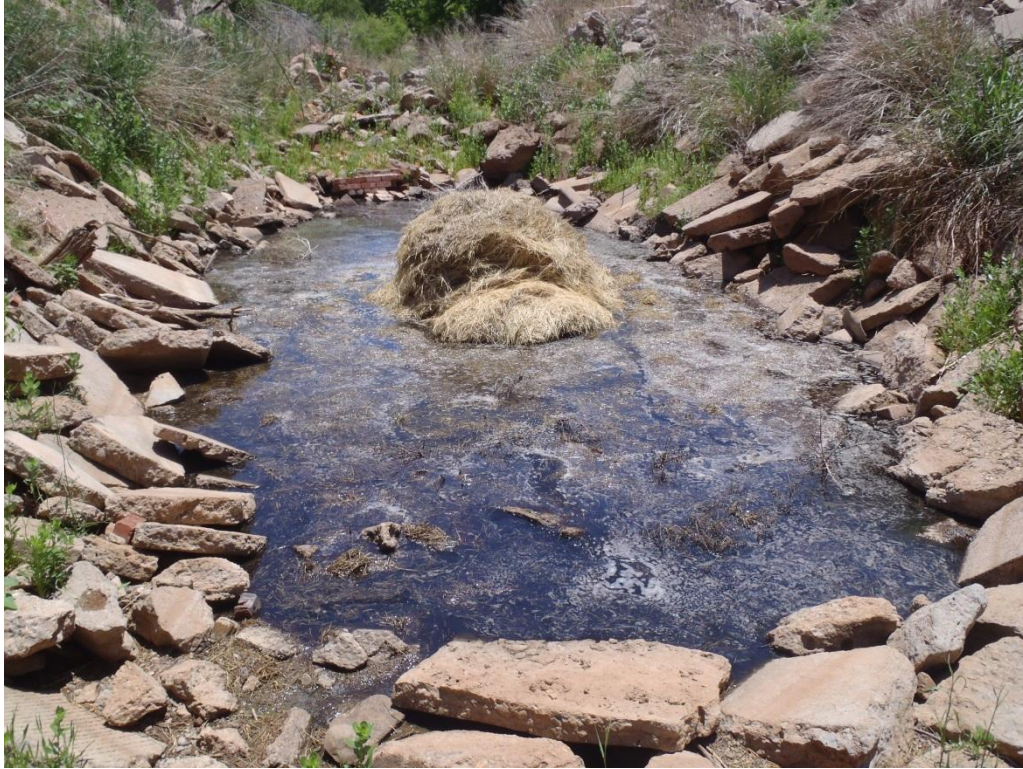
Figure 4.9 Photograph taken of PD003 on June 9, 2013. Photograph is of a pocket of water at about the 185-m transect. Note copious amounts of concrete debris, discarded hay bale and scum on water surface.

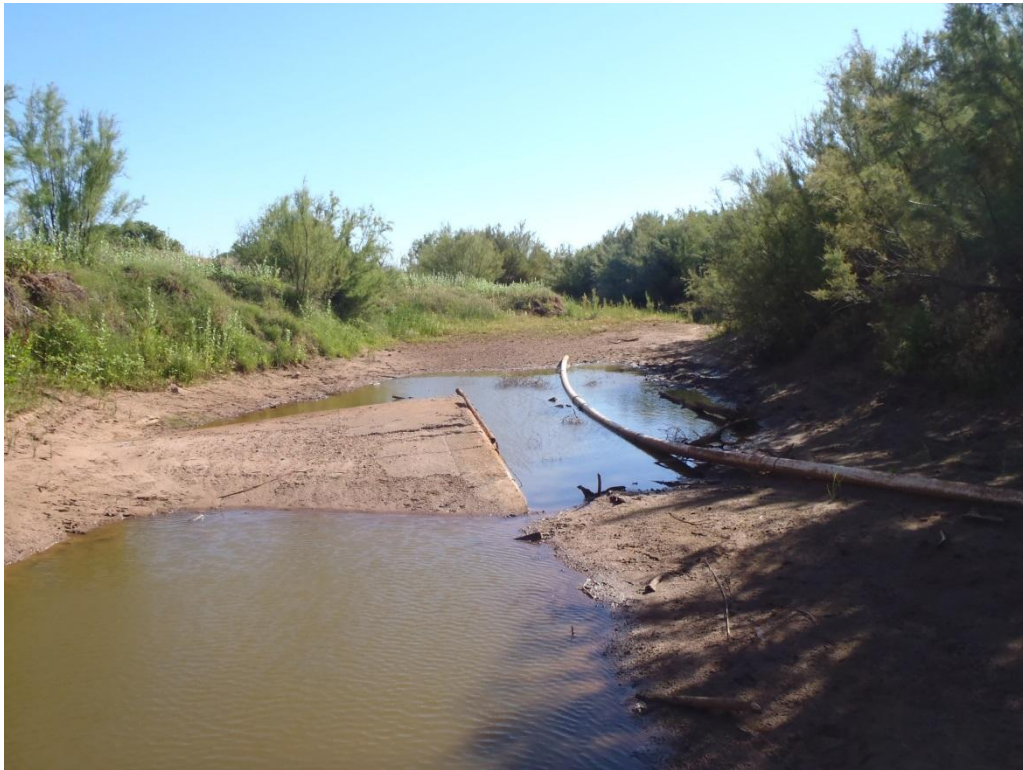
Figure 4.23 Photograph of PD007 taken on Jun10, 2013. Downstream view at the 30-m transect. Note the concrete debris and irrigation pipe.

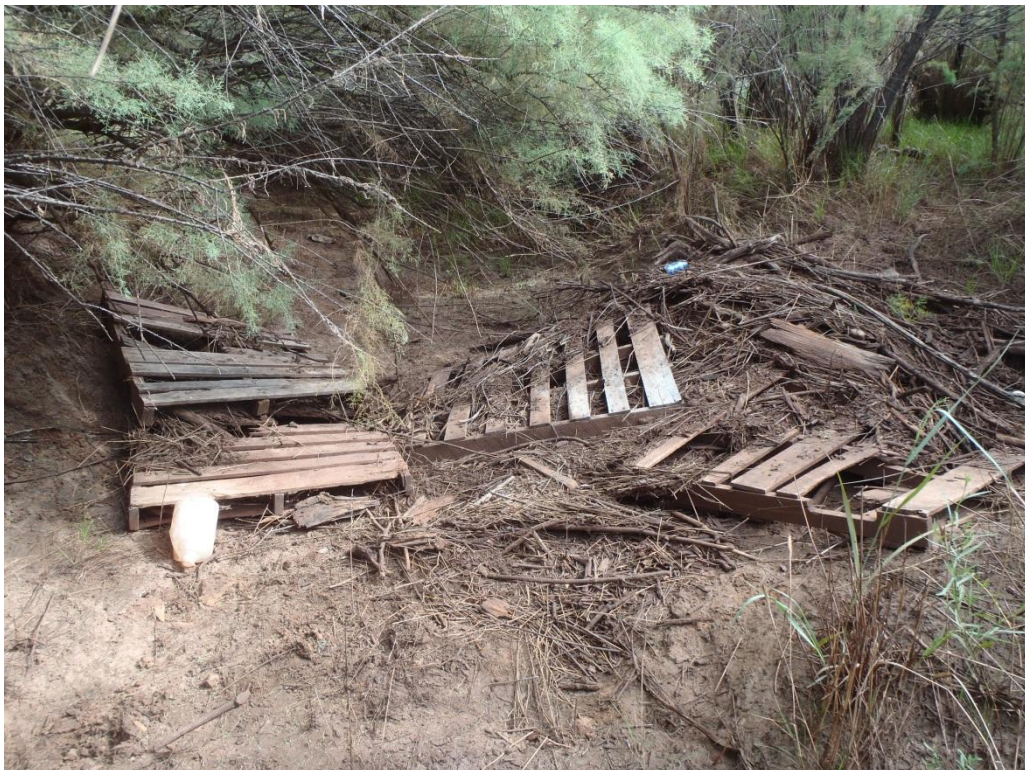
Figure 4.29 Photograph of PD008 taken on August 12, 2013 of garbage accumulation between the 150-m and 270-m transects. Note pallets and household garbage.

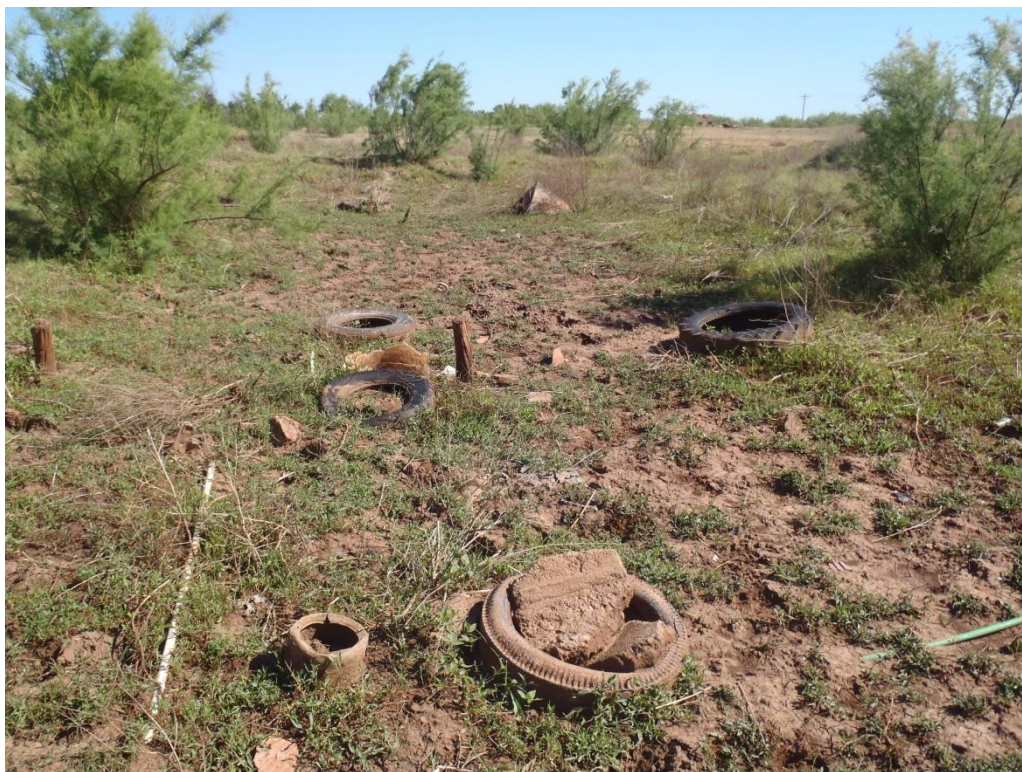
Figure 4.34 Photograph of PD010 taken June 9, 2013 of large debris in creek between the 0-m and 60m transects. Note shrubs on the banks and pasture beyond.

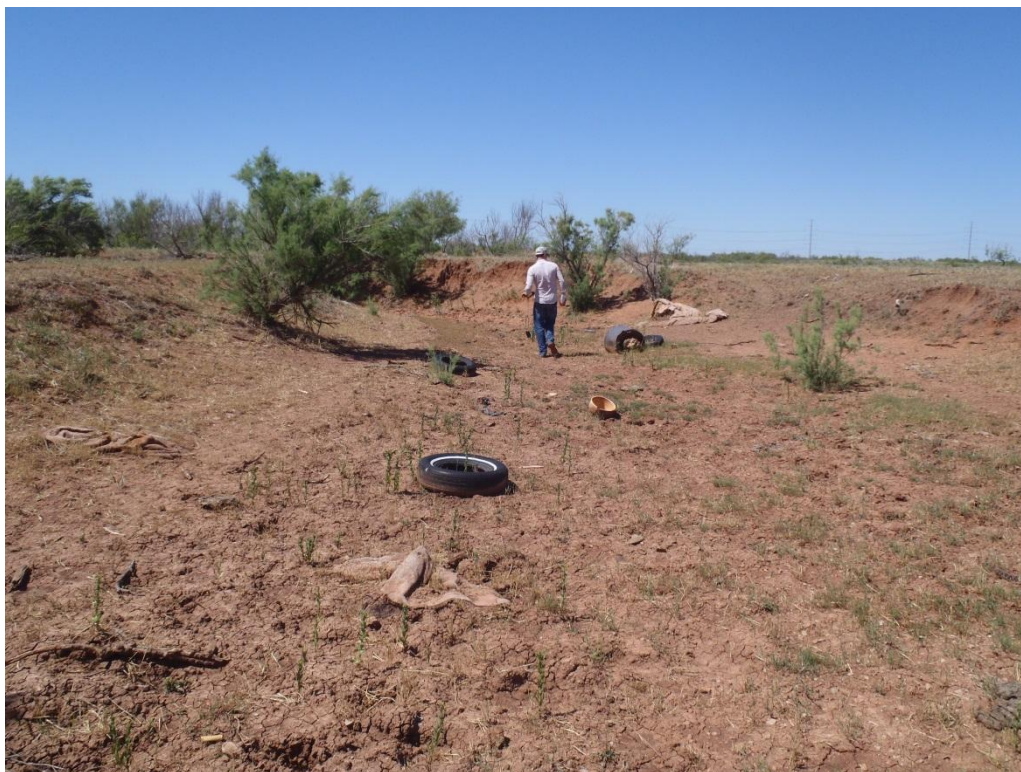
Figure 4.39 Photograph of PD013 taken June 10, 2013 of garbage in the stream bed. Note the open pastureland beyond the riparian area. TIAER personnel in photograph.

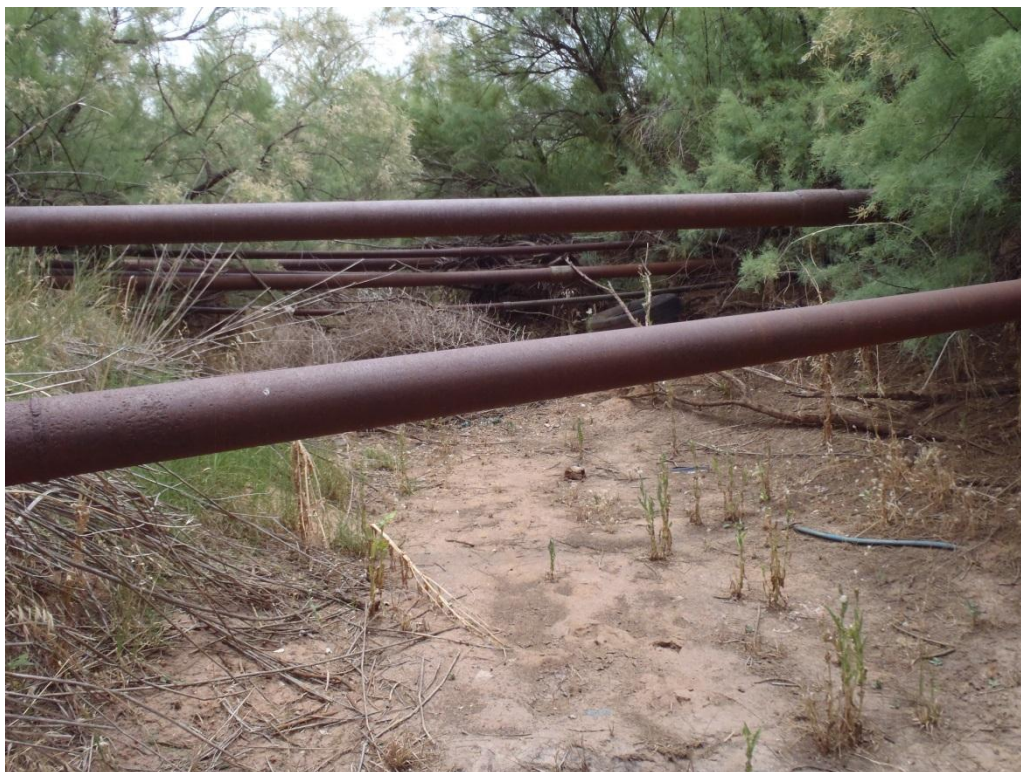
Figure 4.42 Photograph of PD015 taken June 14, 2013 of multiple steel pipes bisecting the creek. Note lack of water, dense bank vegetation and sandy substrate.

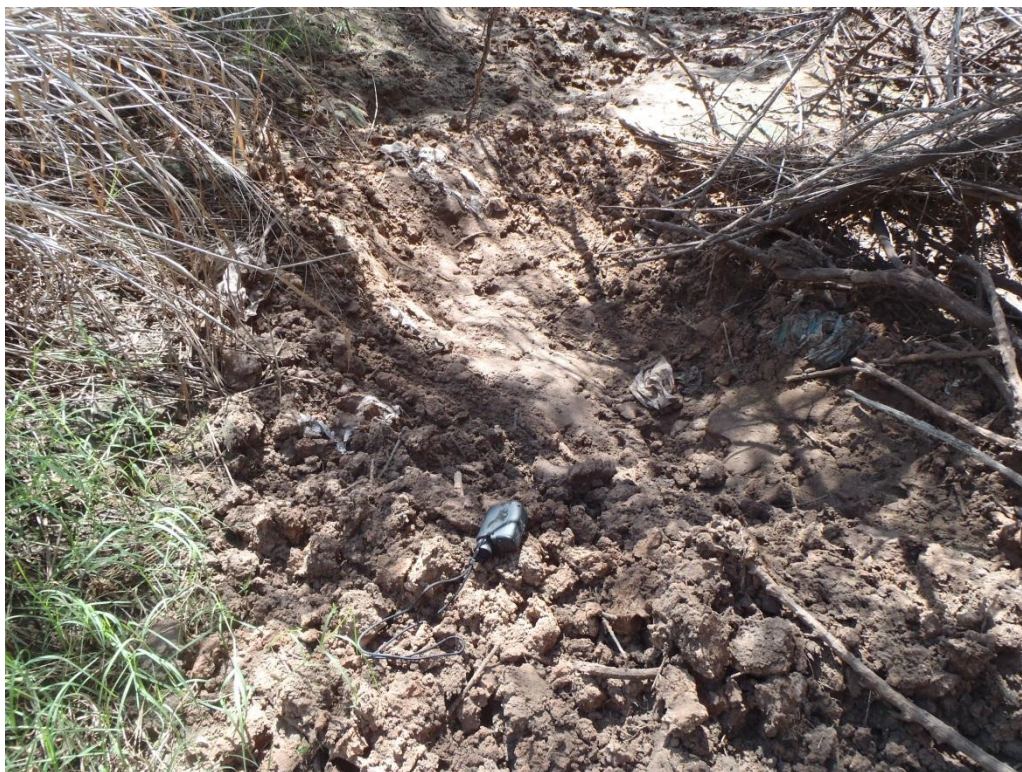
Figure 4.43 Photograph of PD015 taken August 12, 2013 of hog wallow at 180-m transect with range finder placed for scale. Note garbage in the dried mud.

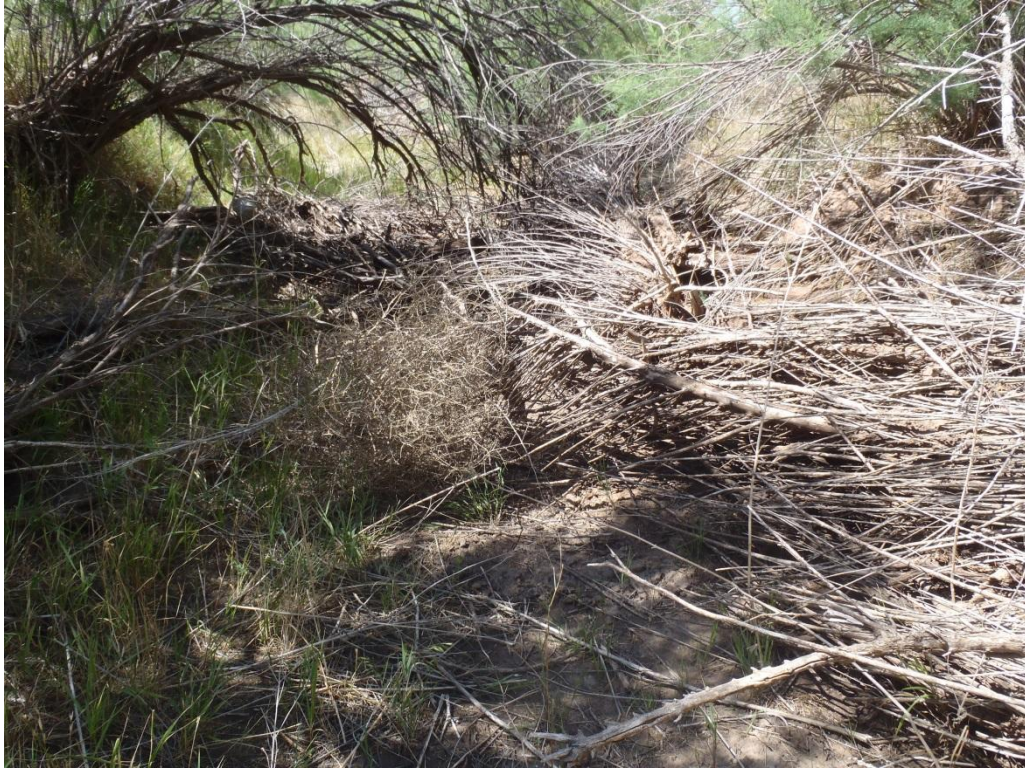
Figure 4.51 Photograph of PD018 taken June 9, 2013. Obstruction at 215-m transect.

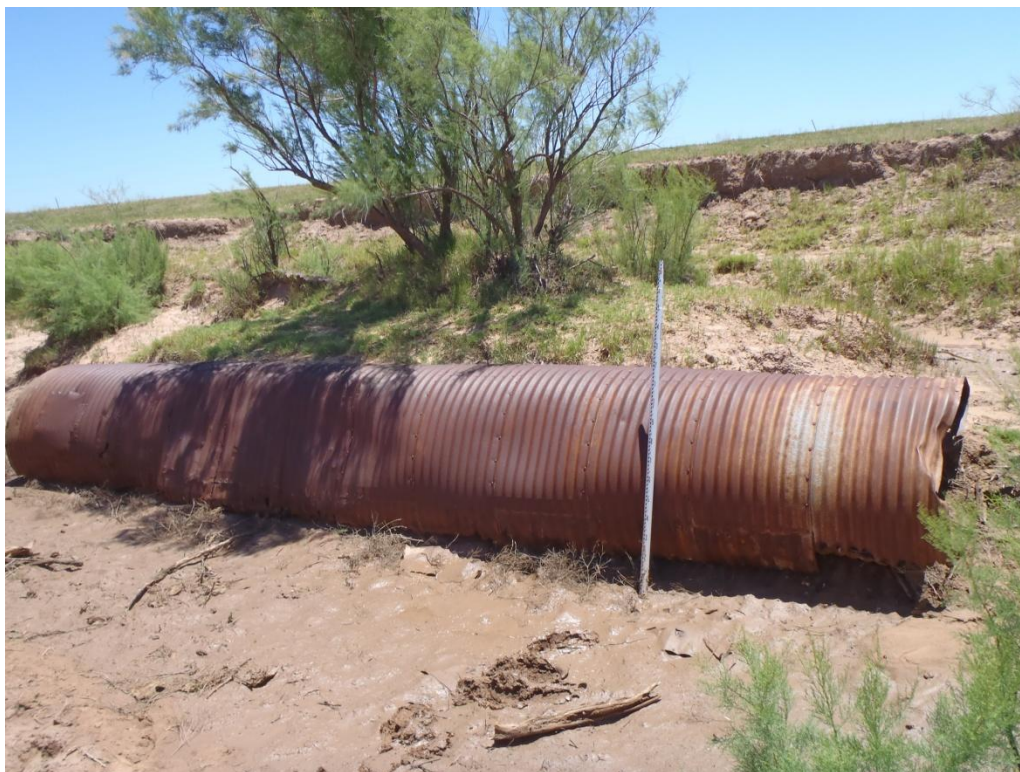
Figure 4.56 Photograph of PD021 taken June 10, 2013 of steel pipe in stream. Note wading rod leaning against it for scale.

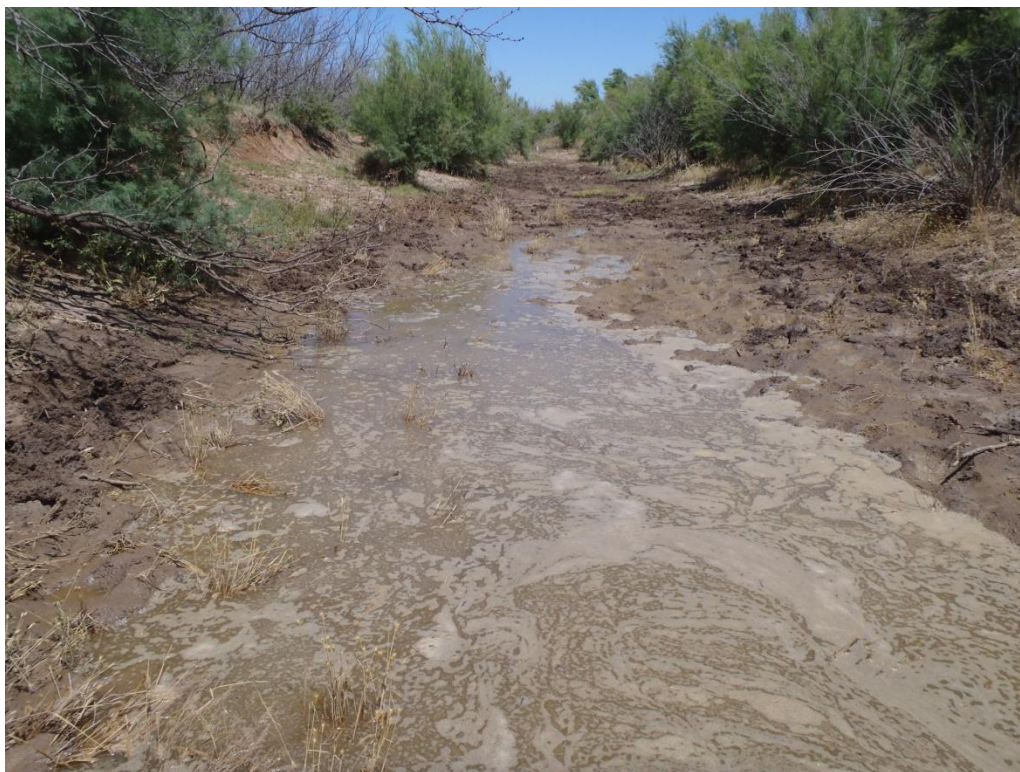
Figure 4.64 Photograph of PD025 taken June 10, 2013. Downstream view at the 150-m transect. Note foam/scum on water and shrub dominated banks.

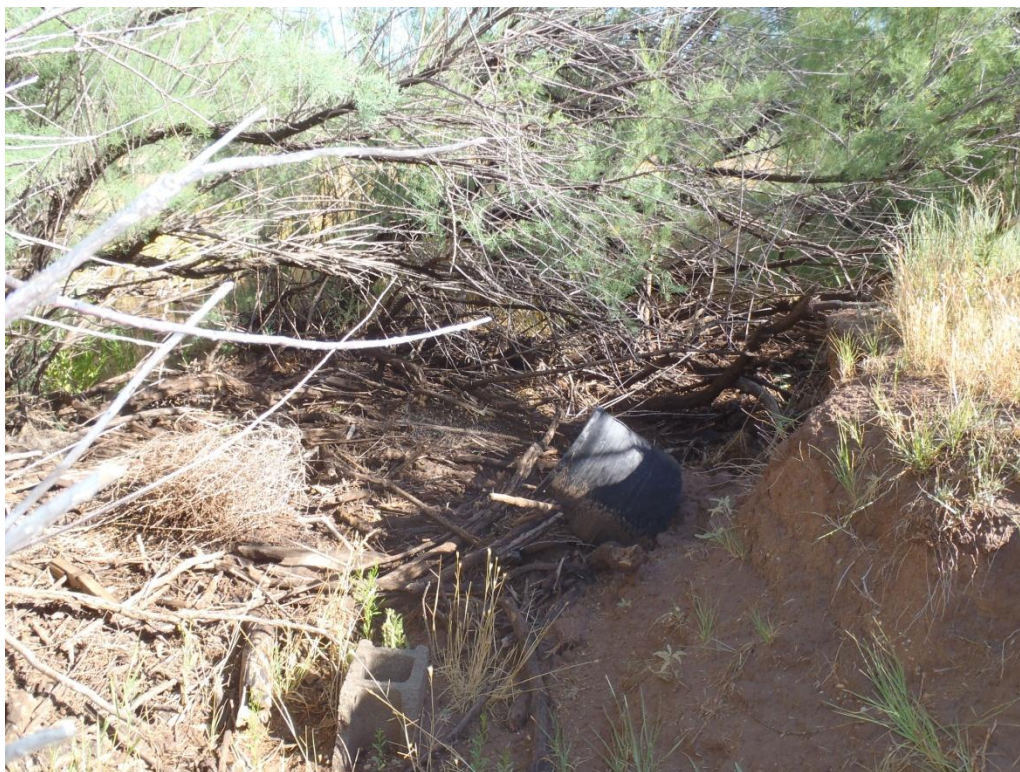
Figure 4.69 Photograph of PD027 taken June 9, 2013. Note log obstruction, livestock mineral bucket and concrete block.

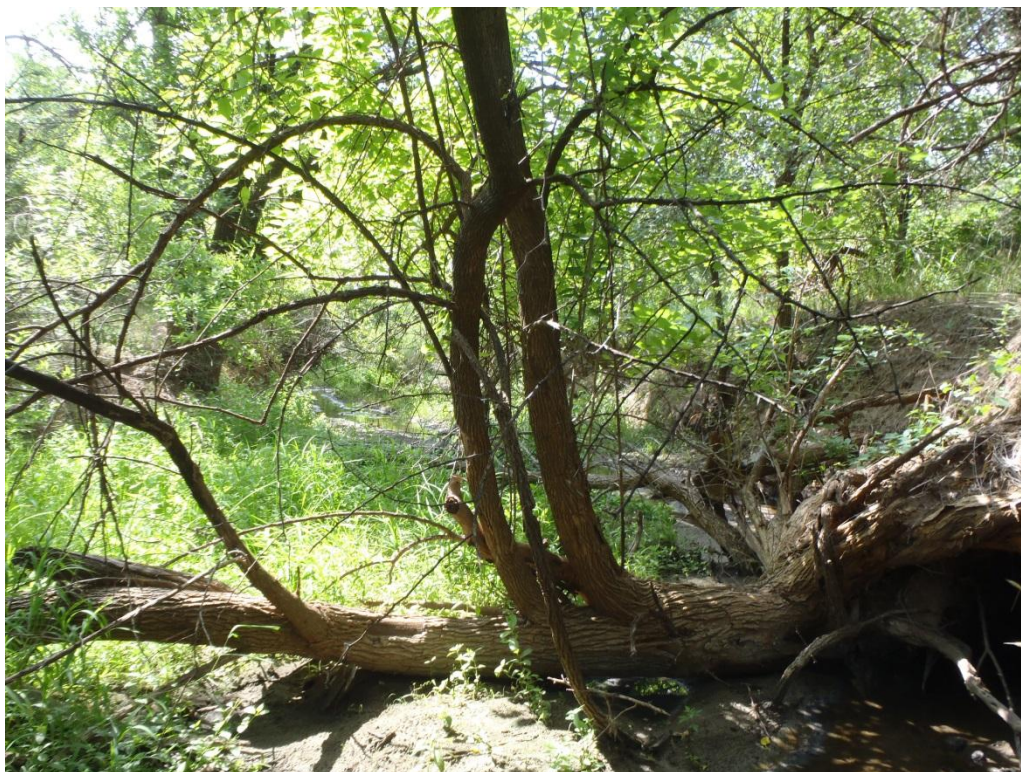
Figure 5.18 Photograph of typical obstructions at Sweetwater Creek Site SW007 taken on July 29, 2013.
